DEPARTMENT OF TRANSPORTATION**DIVISION OF ENGINEERING SERVICES**

Contract #: 04-0120F4Cty: SF/ALA Rte: 80 PM: 13.2/13.9File #: 69.28**WELDING INSPECTION REPORT****Resident Engineer:**Pursell, Gary**Address:** 333 Burma Road**City:** Oakland, CA 94607**Report No:** WIR-003049**Date Inspected:** 02-Jun-2008**Project Name:** SAS Superstructure**OSM Arrival Time:** 1500**Prime Contractor:** American Bridge/Fluor Enterprises, a JV**OSM Departure Time:** 2230**Contractor:** Zhenhua Port Machinery Company, Ltd (ZPMC), Changxing Island **Location:** Shanghai, China**CWI Name:** Tao Lei**CWI Present:** Yes No**Inspected CWI report:** Yes No N/A**Rod Oven in Use:** Yes No N/A**Electrode to specification:** Yes No N/A**Weld Procedures Followed:** Yes No N/A**Qualified Welders:** Yes No N/A**Verified Joint Fit-up:** Yes No N/A**Approved Drawings:** Yes No N/A**Approved WPS:** Yes No N/A**Delayed / Cancelled:** Yes No N/A**Bridge No:** 34-0006**Component:** OBG/Tower**Summary of Items Observed:**

WELDING INSPECTION REPORT

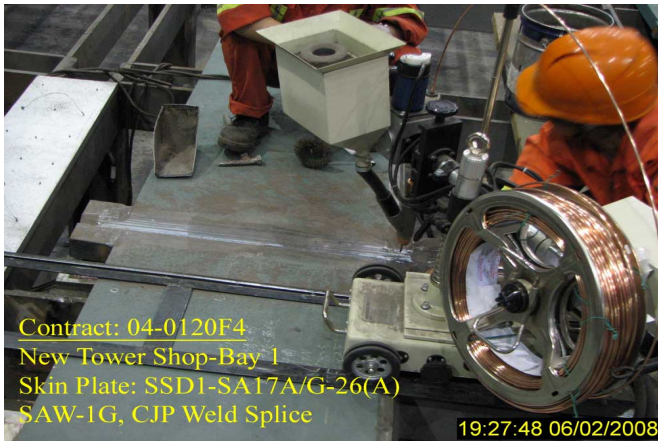
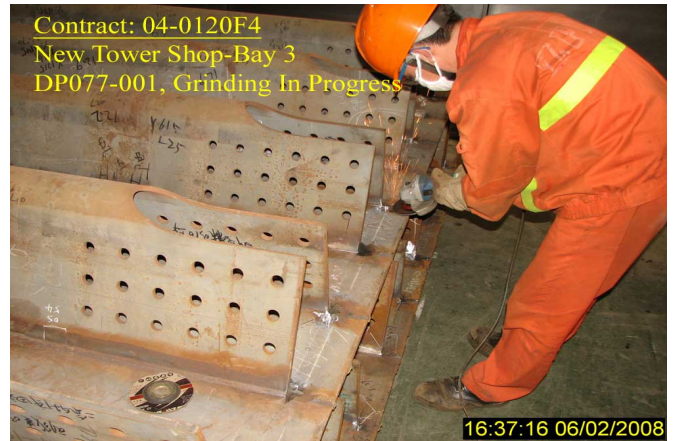
During further observations, the QA Inspector observed deck panels in repair process designated as DP077-001 & DP071-001. The QA Inspector observed personnel also performing grinding at the ends of the closed ribs of these deck panels in the areas where the run off tabs were removed. No repair welding was observed on this date.

The QA Inspector observed ZPMC personnel at multiple locations throughout the bay performing various functions with regard to the fabrication of various tower skin plates. During this observation the QA Inspector observed one location where sub-merged arc welding (SAW) was being performed for a Complete Joint Penetration (CJP) weld splice on a 65mm thick skin plate. The QA Inspector identified the material designation as SSD1-SA17A/G-26A and the cover passes for the 720mm weld splice were in process at this time. The welding was being performed by ZPMC welding personnel Chen Hongxia, welder identification 040460 and the electrical welding parameters, travel speed and interpass temperature was being monitored by ZPMC QC personnel Wang

Sheng. The QA Inspector also observed the welding at this location was being performed to the requirements of welding procedure specification (WPS)-B-T-2221-B-U3c-S-1 & WPS-B-T-2221-B-U3c-S, Revision 1. The QA Inspector reviewed the welding documentation that was recorded by Mr. Wang Sheng along with copies of the noted WPS's. The work in progress appeared to comply with contract specifications.

The following digital images below depict the storage of the five deck panels stored directly on the concrete at the front of the bay, in-process grinding observed on DP077-001 and in-process SAW welding for the CJP weld splice on tower skin plate SSD1-SA17A/G-26A.
